Anaerobic Chamber Explosion

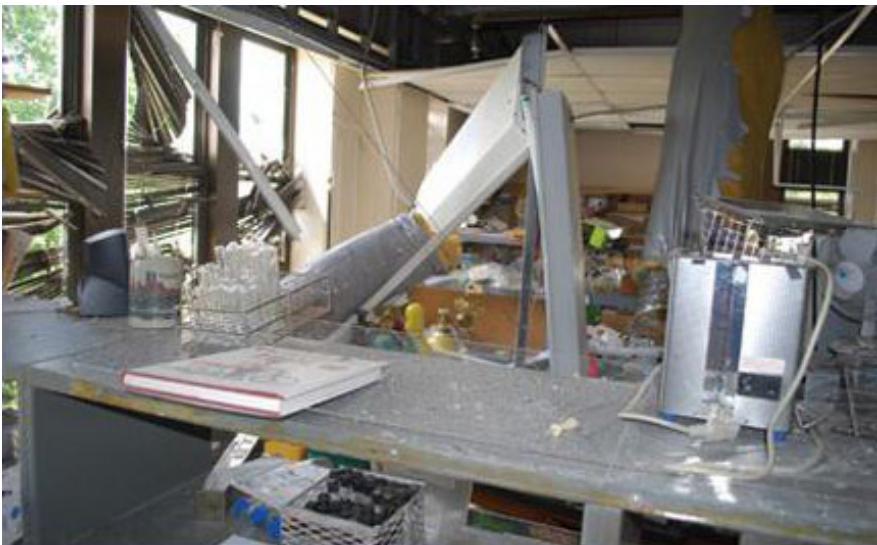
An explosion caused by hydrogen gas used with an anaerobic chamber in a University of Missouri biochemistry research lab on Monday injured four people and destroyed the laboratory. A report from *Chemical & Engineering News* summarizes the incident. Four people were injured in the explosion. One person is hospitalized. Damages are expected to exceed \$750,000.

Explosion at University of Missouri in 2012. Photo courtesy C&EN

Use non-flammable mixtures of hydrogen (4%) where possible.

Always purchase the smallest cylinder of flammable gas needed. Avoid purchasing full sized cylinders.

Verify the identity of gases before use. It is not uncommon to received incorrect gas mixtures.

On start up flush chambers with nitrogen gas instead of hydrogen mixtures.

Leak test the chamber on start up.

Know how to purge the air lock on your anaerobic chamber. Improper use of the air lock can admit oxygen into the chamber.

Monitor the oxygen concentration in the chamber. Replace oxygen indicators as recommended by the manufacturer.
